Dust or Gas Explosion: Case Study of Dryer Explosion and Design Venting

Scott G. Davis
GexCon US
7735 Old Georgetown Rd., Suite 1010
Bethesda, MD 20814
sgdavis@gexcon.com

Prepared for Presentation at
American Institute of Chemical Engineers
2010 Spring Meeting
6th Global Congress on Process Safety
San Antonio, Texas
March 22-24, 2010

Keywords: dust explosion, gas explosion, explosion venting

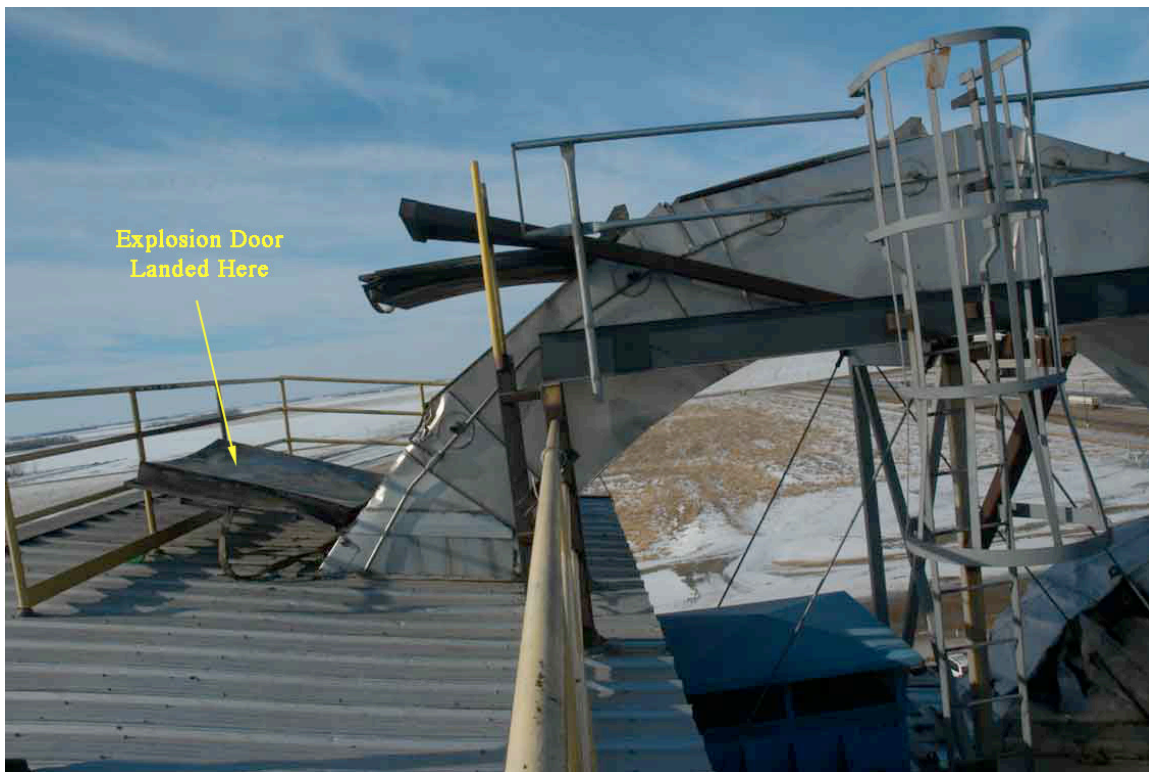
GexCon engineers were retained to investigate an explosion that occurred at approximately 3:16 am in a process facility. The explosion occurred in one of two single burner, recirculating solids ring dryers. No one was reported injured as a result of the explosion, however the explosion caused significant damage to the dryer and minor damage to sections of the facility. No one was reported injured as a result of the explosion. All four of the explosion panels on the external ring duct, the two explosion panels on the dryer cyclone header, and the pre-separator explosion panel had opened during the explosion. For the purpose of this study, hinged explosion doors and panels are used interchangeably. In addition, a manual entry door into the hot air box was blown open during the explosion. Two of the explosion panels P1 & P2 (discussed later) on the external ring duct were separated from their hinges, with one landing on the upper roof section next to explosion panel P4 (see Figure 1), while the other panel fell back through the roof of the facility (see Figure 2).

Figure 1: Explosion panel (door) from external ring duct that landed on the upper roof

2. The designer of the dryer should have provided a sufficient means of securing the explosion doors on the ring dryers and failed to meet the requirements of NFPA 68 *Guide for Venting of Deflagrations*, which states, “For personnel safety, the door or panel should be designed to remain intact and to stay attached.”

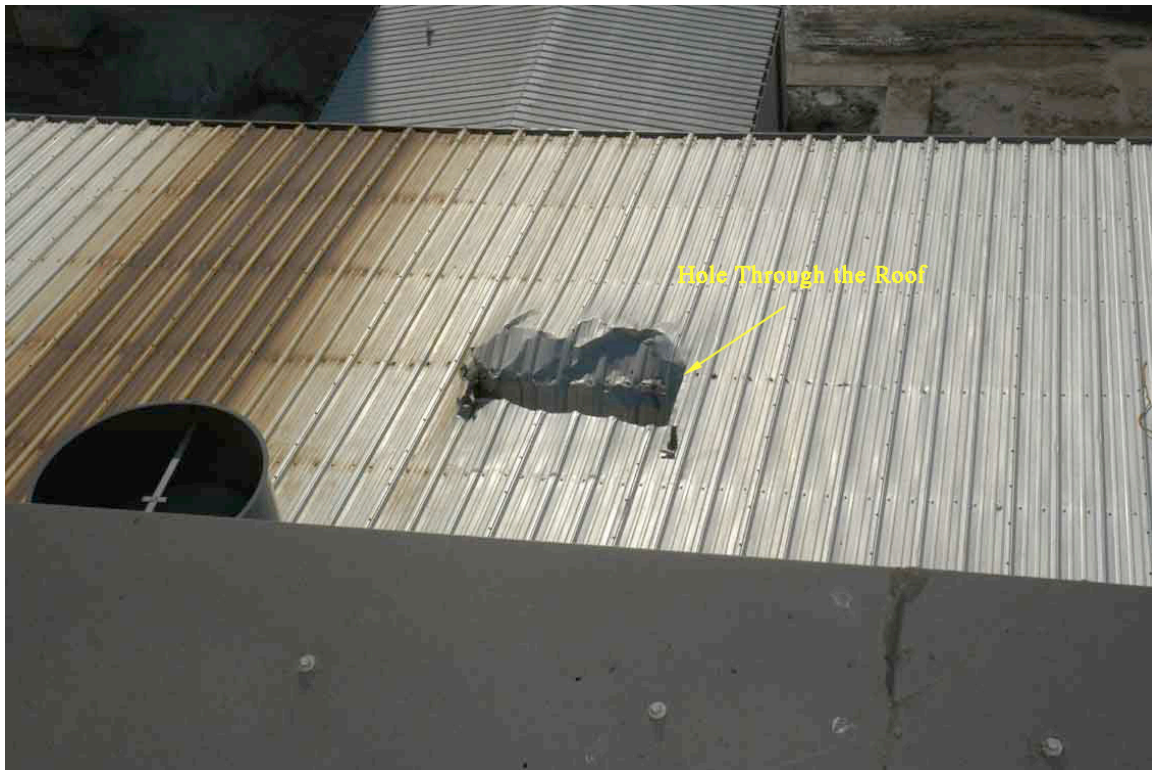
Figure 2: Explosion panel (door) that penetrated the roof

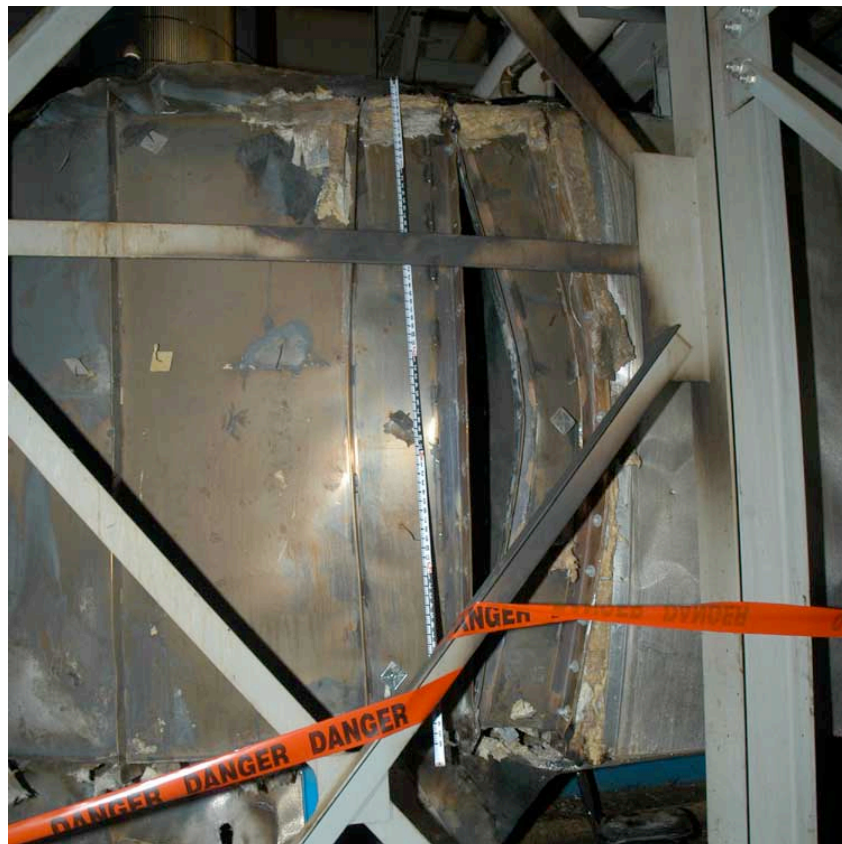
The explosion also caused a section of the recycle duct to rupture near the 90° turn, which can be seen in Figure 3. Plant personnel heard one large “boom” followed by multiple smaller explosions.

Figure 3: Ruptured section of the recycle duct

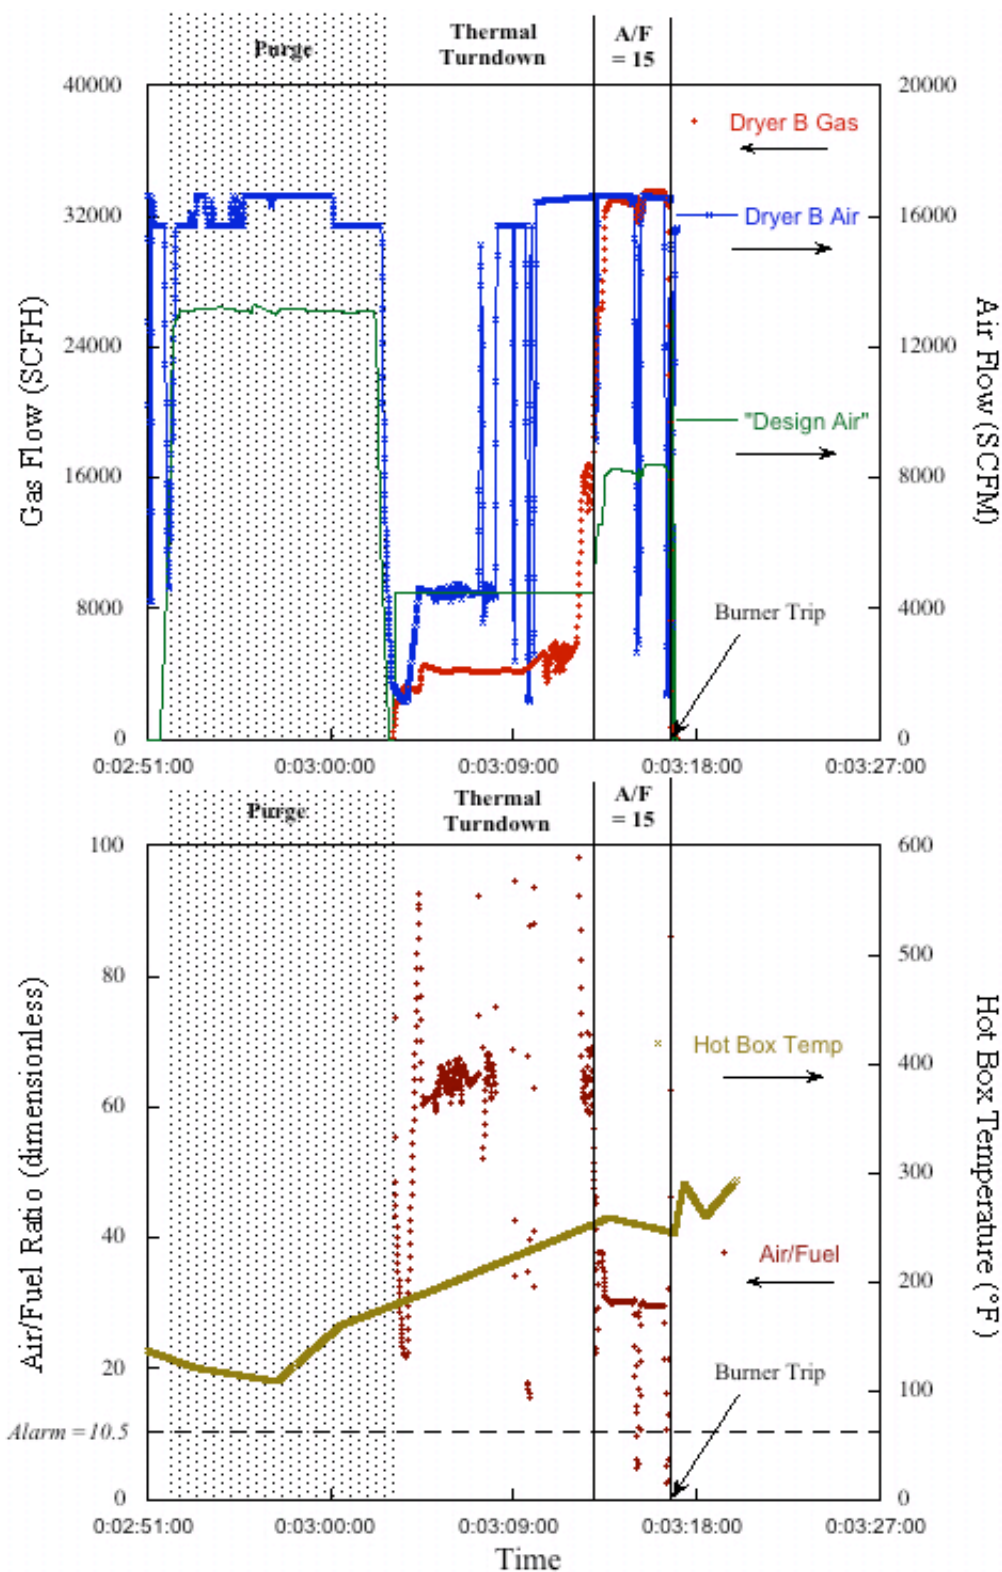
The burner on the dryer was put into purge at approximately 2:51 am, 5 to 6 minutes following a previous burner trip and approximately 25 minutes prior to the explosion. Figure 7 shows several process variables (gas flow rate, combustion air flow rate, hot box temperature and air/fuel ratio) during this particular relight of the burner in Dryer B. Also shown in the top graph of Figure 7 is “Design Air” which is a calculated combustion airflow rate that should have been present during the relight and will be discussed below.

Figure 7: Process data for the 2:51 am relight on the day of the incident

The process data suggests that the mass flow meter continued to fail for about 4 minutes until the burner tripped at approximately 3:16 am. The mass flow meter was not continuously in the

failure mode and would occasionally transmit the actual signal. The ratio controller has a programmed over-range alarm programmed into the unit. The over-range alarm was set to activate at signal equal to or greater than 23.5 mA. However, during the failure mode of the mass flow meter during this particular relight, it transmitted signals at approximately 21.7 mA (less than 23.5 mA). When receiving this signal, the response of the ratio controller was to drive the combustion air damper to the closed position in an attempt to maintain the pre-determined air/fuel ratio set point.

Despite the possibility of the recorded process data not capturing all the details of the combustion air, it did record on at least three occasions when the mass flow meter was operating and the air/fuel ratio dropped below the alarm setting of 10.5/1. For the first two occasions, the data indicates that the alarm did not activate because the mass flow meter did not stay in this mode for 4 seconds. Before 4 seconds had passed, the mass flow meter went back into failure mode and transmitted a combustion air signal of approximately 21.7 mA, thus resulting in artificially high air/fuel ratios. Right before the burner trip, the recorded air/fuel ratio dropped as low as 2.4, corresponding to an equivalence ratio of 4.1 or an extreme fuel rich condition. Fuel rich conditions lead to incomplete combustion, including unburned natural gas, hydrogen and carbon monoxide. If the recorded signals from the mass flow meter are valid, extreme fuel rich conditions led to unburned natural gas, hydrogen and carbon monoxide being circulated in the dryer in an oxygen-starved environment.

- a. On the dryers that use the incident flow meter for combustion air and the incident air-to-fuel ratio controller, the internal jumper pins for the Failure Mode Alarm on the mass flow meter should be set to the low position for combustion air (output signal driven below 3.75 mA). In the event the ratio controller interpreted this as an actual signal, it would drive the air damper fully open causing fuel-lean conditions to exist in the dryer.

- b. The over/under range signals emitted from the mass flow meters need to be detected by the combustion management system and initiate a burner shutdown.

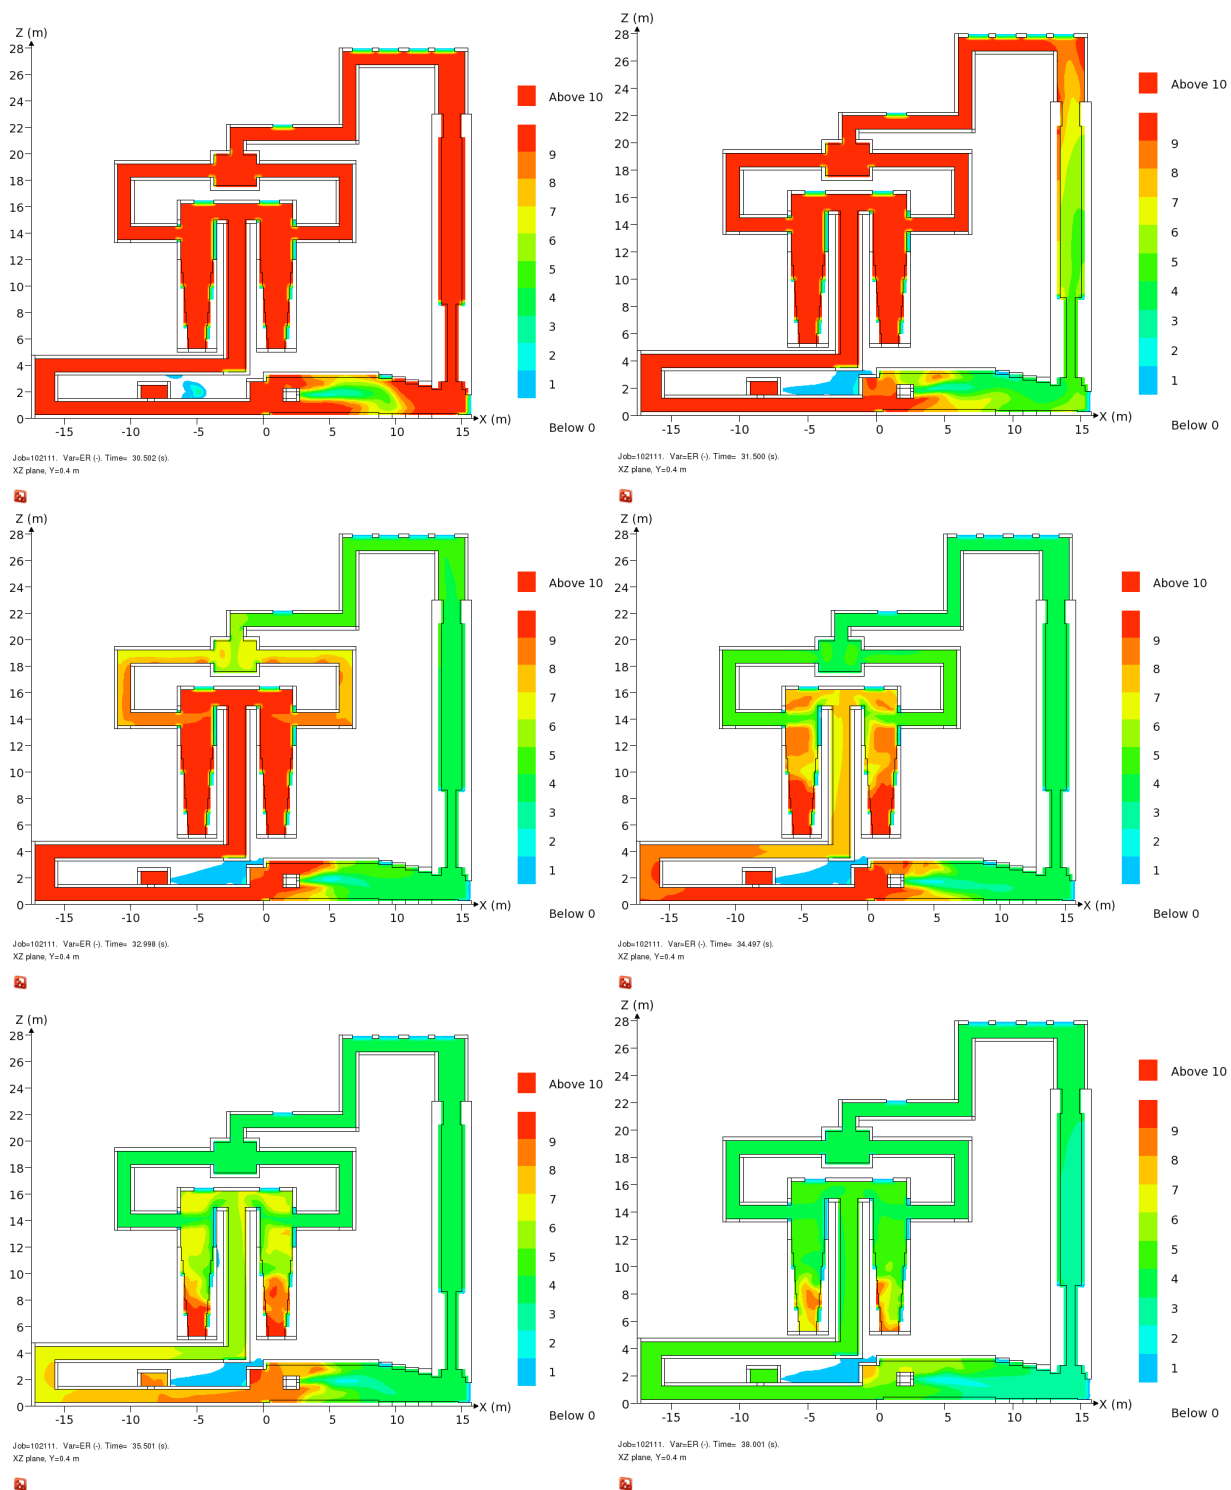
In Figure 8 the development of the gas mixture during the 8-second air purge is shown. Initially the whole system is filled with a fuel-rich composition with approximately 10 times more fuel than optimum for combustion. The gas mixture, with large fractions of hydrogen and CO, is estimated to be flammable at equivalence ratios (ER) from 0.5 (the lower flammability limit – LFL) to 4.7 (the upper flammability limit – UFL). The highest burning velocity is estimated to occur at ER=1.5. For concentrations near the flammability limits (e.g. ER above 3.5) one can expect quite slow, if any, flame propagation, which will likely be dominated by the strong circulation flow of the dryer system. The high turbulence levels within the dryer may also prevent ignition of such weakly burning mixtures. As the air purge continues, the equivalence

As the air purge at the burner is initiated, the simulation results shows a small air pocket downstream of the burner that quickly gets diluted to non-flammable or barely flammable concentrations. Once this barely flammable plug of gas (that has the additional air from the purge) has circulated one loop in the system and starts receiving air injected from the purge for the second time, a much more reactive pocket of flammable fuel-air is formed. Both from process data and the simulation results, it can be seen that it takes approximately 6 seconds for the flow within the dryer to complete one loop in the system. The simulations show that the highly flammable pocket of fuel-air grows rapidly after 6 seconds. The explosion takes place approximately 8 seconds after the air purge at the burner is started. However, if ignition had been further delayed to say 10 seconds, a much larger flammable gas cloud would have been present and a much stronger explosion could have occurred. In Figure 9 the development of the flammable cloud downstream of the burner air purge is shown for the studied ignition locations.

Figure 8: Simulated fuel-air ratio (equivalence ratio) in system during 8 seconds of air purging (starting at time=30s). The estimated flammable range for the actual mixture is from ER=0.5 (LFL) to ER=4.7 (UFL)

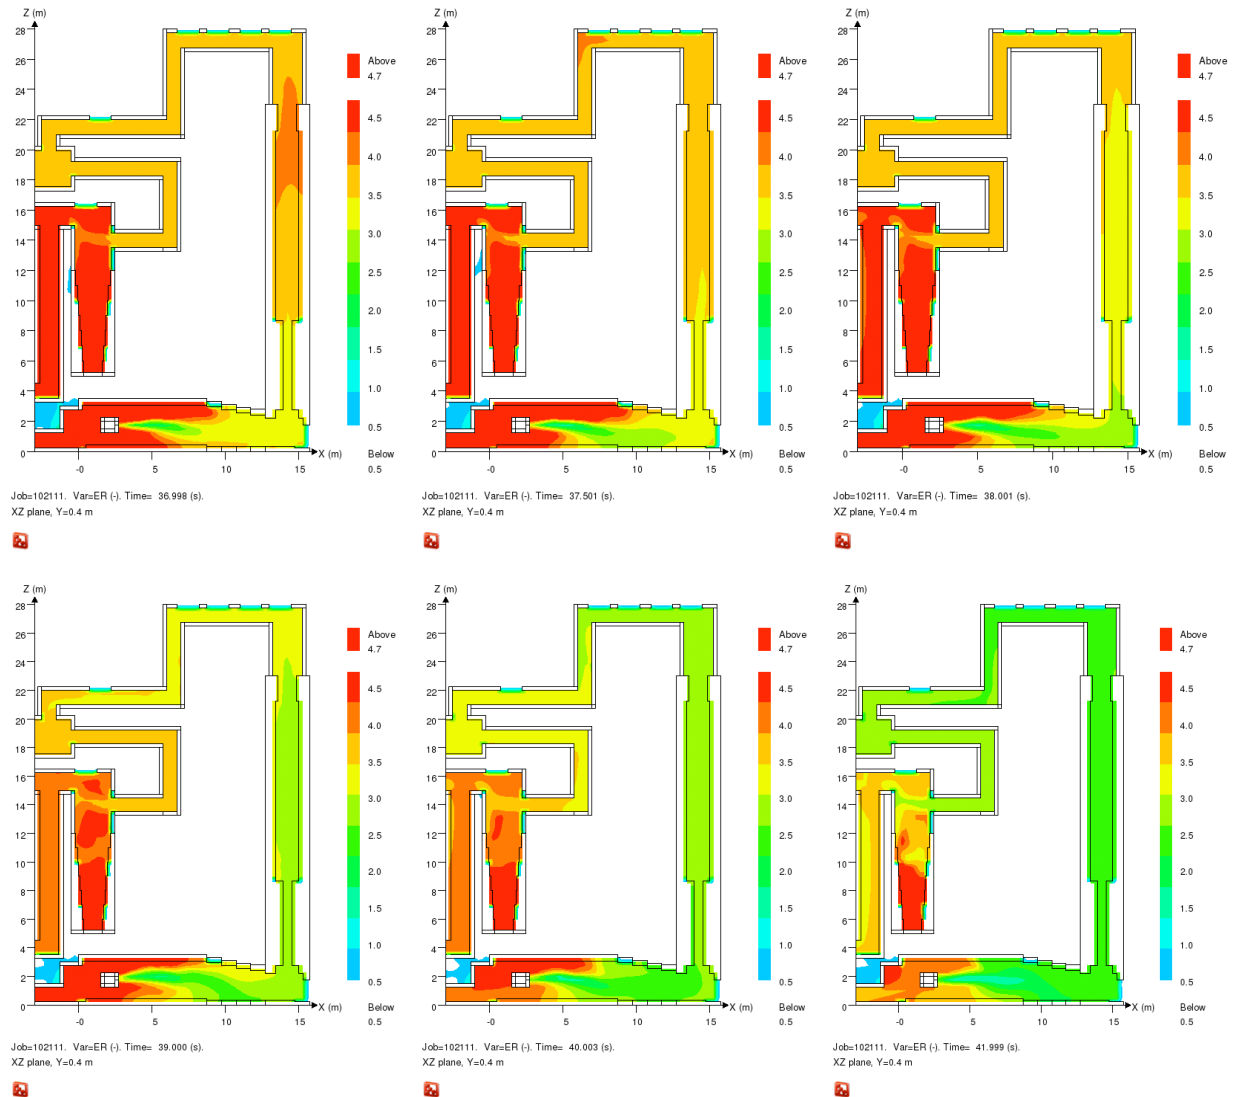
There are some uncertain parameters in the present work, yet the ignition appears to have occurred approximately 7.5 to 8.0 seconds after the burner air purge was initiated. While the ignition location is in the region downstream of the burner, its exact location is not known. In addition, small deviations exist in our modeled dryer (e.g., definition of bends) and there are uncertainties associated with the exact composition of the gases circulating within the dryer. Therefore, we also evaluated small deviations in ignition time compared to observed times. More specifically, we evaluated a few different ignition locations and ignition times to see if ignition scenarios can be determined that partly or fully explain the observed damage level and sequence of explosion panel opening. One additional parameter that is not known is the opening characteristics for the access door in the hot box (P8). If this door is stronger than the vent panels this can have a significant effect on explosion pressures since the door is very close to the assumed gas cloud location and ignition. For most cases, this door has been assumed to have the same strength as the explosion panels (50 mbar), but sensitivity calculations have been performed with a higher opening pressure (100 mbar).

Figure 9: Gas cloud concentrations downstream of air purge location at different studied ignition times, 7s, 7.5s, 8.0s, 9.0s, 10s and 12s. The estimated flammable range for the actual mixture is from ER=0.5 (LFL) to ER=4.7 (UFL)

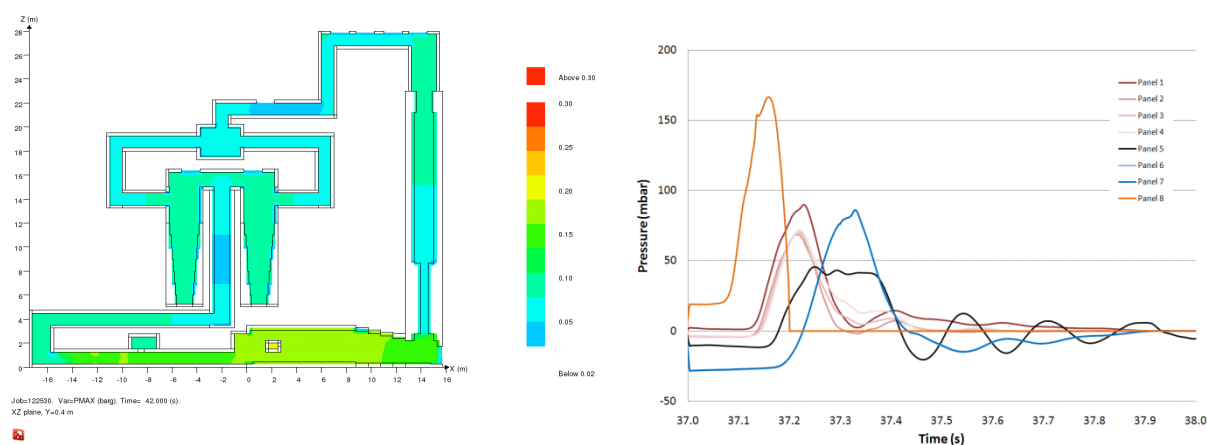
All the scenarios with ignition at 7.0 seconds within 2.5m of the burner can replicate many of the characteristics of the explosion. Panels 1-4 (red in the panel pressure plots) and 6-7 (blue), in addition to the hot box access door (orange), opened, whereas panel 5 (black) in general did not yield for these scenarios. There is however a 100ms time delay from the opening of panels 1-4 to the opening of panels 6-7 (these were reported to have near-simultaneous opening times in the incident). The exact resolution for the recorded event log is unknown and this scenario may be close to the actual opening times. For all these scenarios the pressure level is around or slightly above the required design strength as recommended by NFPA 68. However, we do not have sufficient knowledge about the actual design strength to judge whether these pressure loads may explain the observed damage to the dryer. The ignition located 5m downstream from the burner also shows many characteristics similar to those observed in the previous case, except that panel 5 yielded within 90ms of panel P1. This scenario may be consistent with the explosion panel switch being “stuck” and not properly recording the opening of P5.

Figure 10: Explosion scenario with ignition at 7s (ignition position is 2.5m downstream of burner and door opening pressure 100 mbar). The left picture shows the distribution of maximum pressure seen in the system during the explosions, whereas the right picture shows the recorded explosion panel pressures.

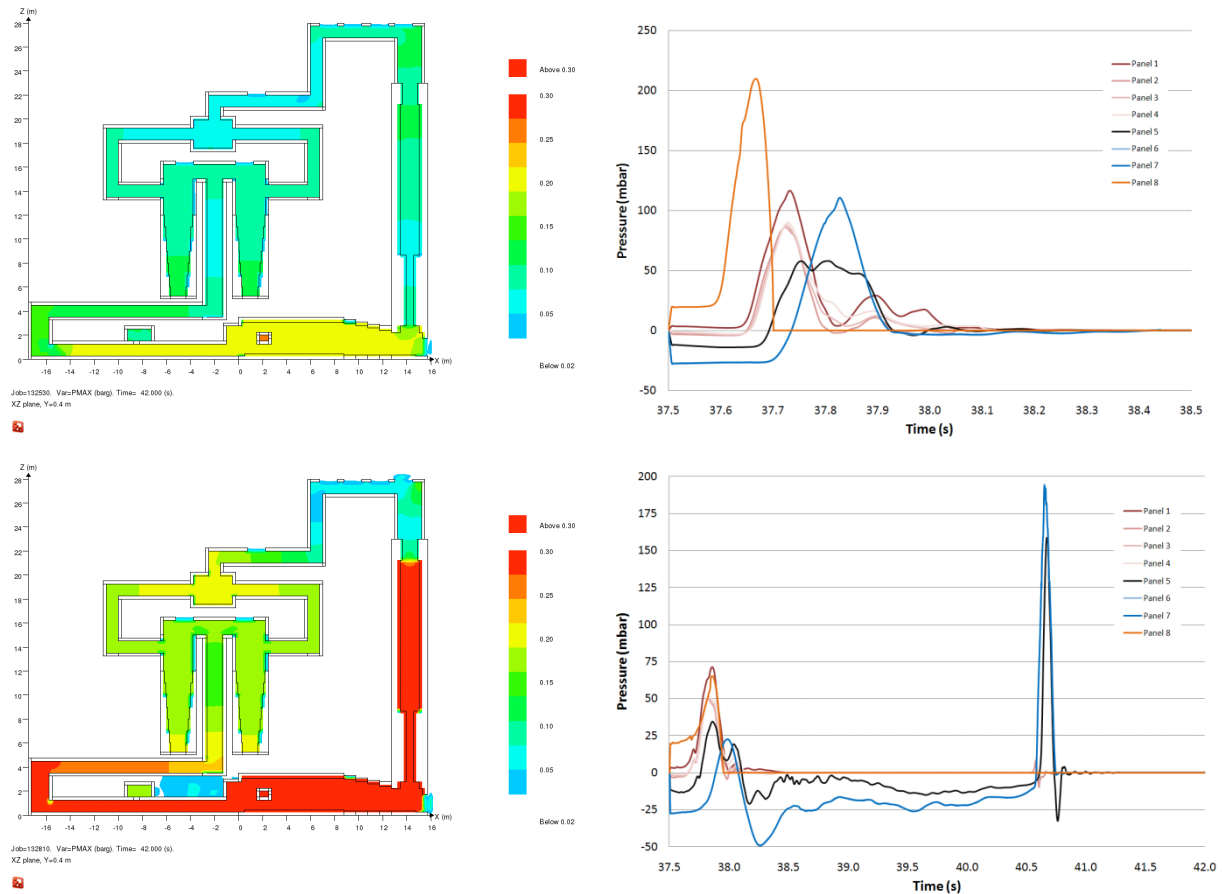
Seven different ignition scenarios with ignition at 7.5 seconds were simulated. Two of these cases are shown in Figure 11. In general, very similar trends as those reported for the 7.0-second ignition time are observed, except that pressure levels are slightly higher. This may be more realistic with regard to the observed damage to the duct upstream of the burner, however, due to the increasing pressure, panel 5 starts opening at times very close to panels 1-4. The first scenario shown in Figure 11 is one example of this group of scenarios.

At one ignition location for the 7.5-second ignition case, panel 5 did not open with panels 1-4 but opened 3 seconds later consistent to what was recorded in the process data. This scenario is with the ignition in the bend downstream from the hot box and this case is shown in Figure 11. Here it can be seen that panels 1-4 and the access door (P8) open early, and that panels 5, 6 and 7 open violently 3 seconds later. In the actual explosion only panel 5 opened with a delay at the same time an explosion panel for the cyclone closed. Therefore this scenario has been ruled out as it does not properly reconcile the sequence of events and includes a potentially unrealistic ignition source remote from the burner.

Figure 11: Two explosion scenarios with ignition at 7.5s. The left pictures show the distribution of maximum pressure seen in the system during the explosions, whereas the right pictures show the recorded explosion panel pressures. The upper plot is for ignition 2.5m downstream of burner and door opening pressure 100 mbar, whereas the lower plot is for ignition just downstream of the hot box with door opening pressure 50 mbar.

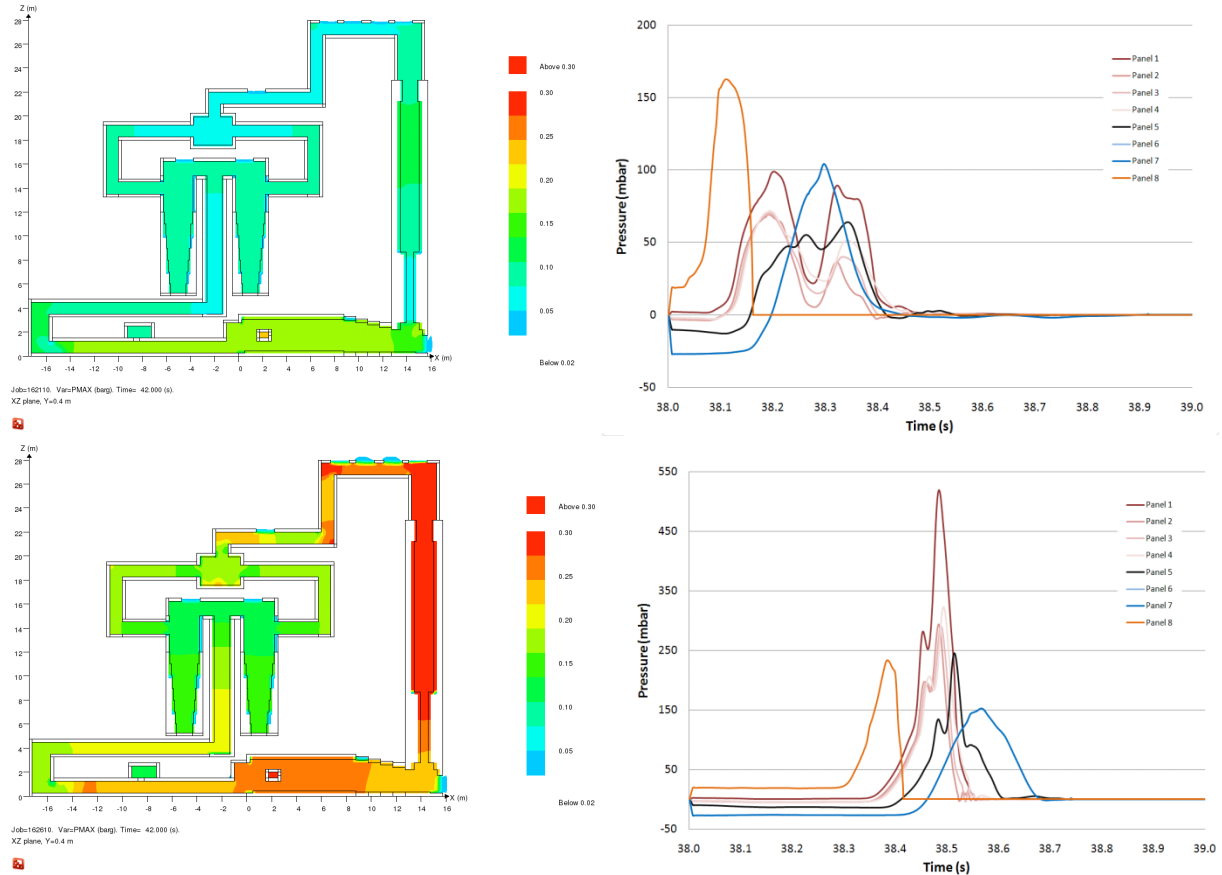
Three different scenarios with ignition at 8.0s were simulated. Two of these cases are shown in Figure 12. For ignition near the burner, similar trends as seen with the 7.0- and 7.5-second ignition cases were observed, which can be seen in the upper plots of Figure 12. Explosion pressures increase considerably if the ignition location is moved further downstream of the burner, where the pressure distribution for ignition located 5m downstream of burner is shown in the lower plot of Figure 12. High pressures reach panels 1-4, and these could help explain that

the hinges of panel 1 broke and made the panel into a projectile during the explosion. For scenarios with an even more delayed ignition, the flammable gas cloud at the time of ignition is larger and more severe explosions are observed. These severe explosions are not consistent with the observed damage.

Figure 12: Two explosion scenarios with ignition at 8.0s. The left pictures show the distribution of maximum pressure seen in the system during the explosions, whereas the right pictures show the recorded explosion panel pressures. The upper plots are for ignition near the burner, whereas the lower plots are for ignition 5m downstream of the burner (door opening pressure is 50 mbar in both cases).

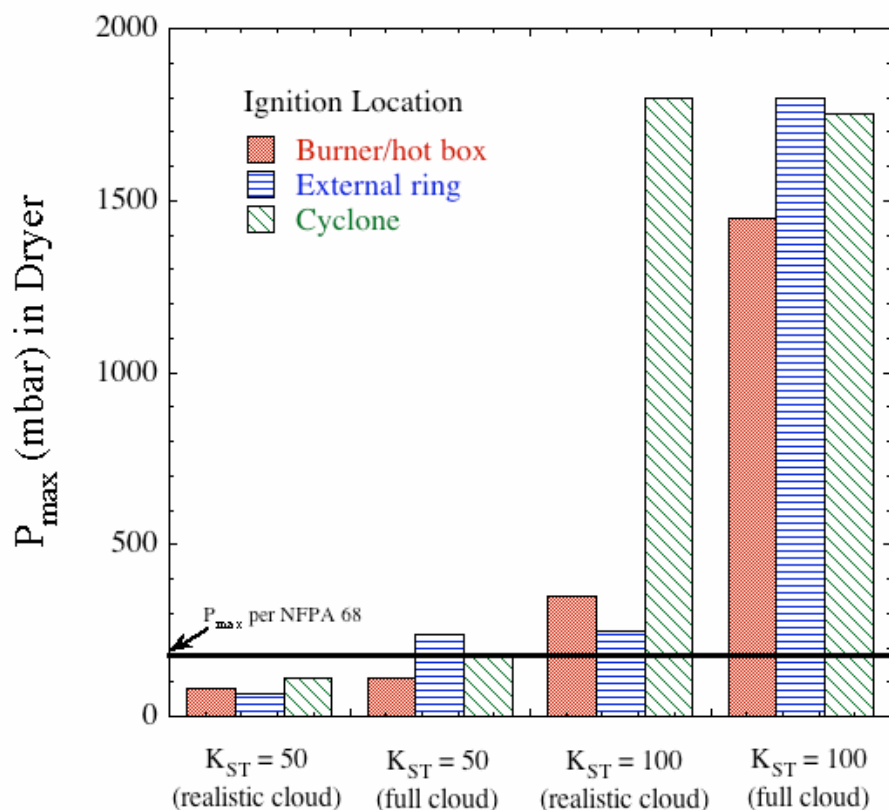
In Figure 13 the maximum pressures observed in the dryer are reported for all simulated dust explosion scenarios for an initial temperature of 120°C. Provided the NFPA 68 recommendations on system strength are followed (system should withstand 2.5 psi), the simulations predicted that the system should generally be well designed to resist dust explosions for dusts with a K_{ST} of 50 bar-m/s, which is double the reactivity reported for the actual dust. The dust cloud sizes and conditions were overly conservative (filling the whole dryer with worst-case reactivity dust).

In Figure 13 it can also be seen that if the dust reactivity is doubled ($K_{ST} = 100$ bar-m/s), the explosion pressures are predicted to increase almost one order of magnitude for some scenarios.

Figure 13: Overview of overpressures obtained in simulated dust explosion scenarios at initial temperature 120°C.

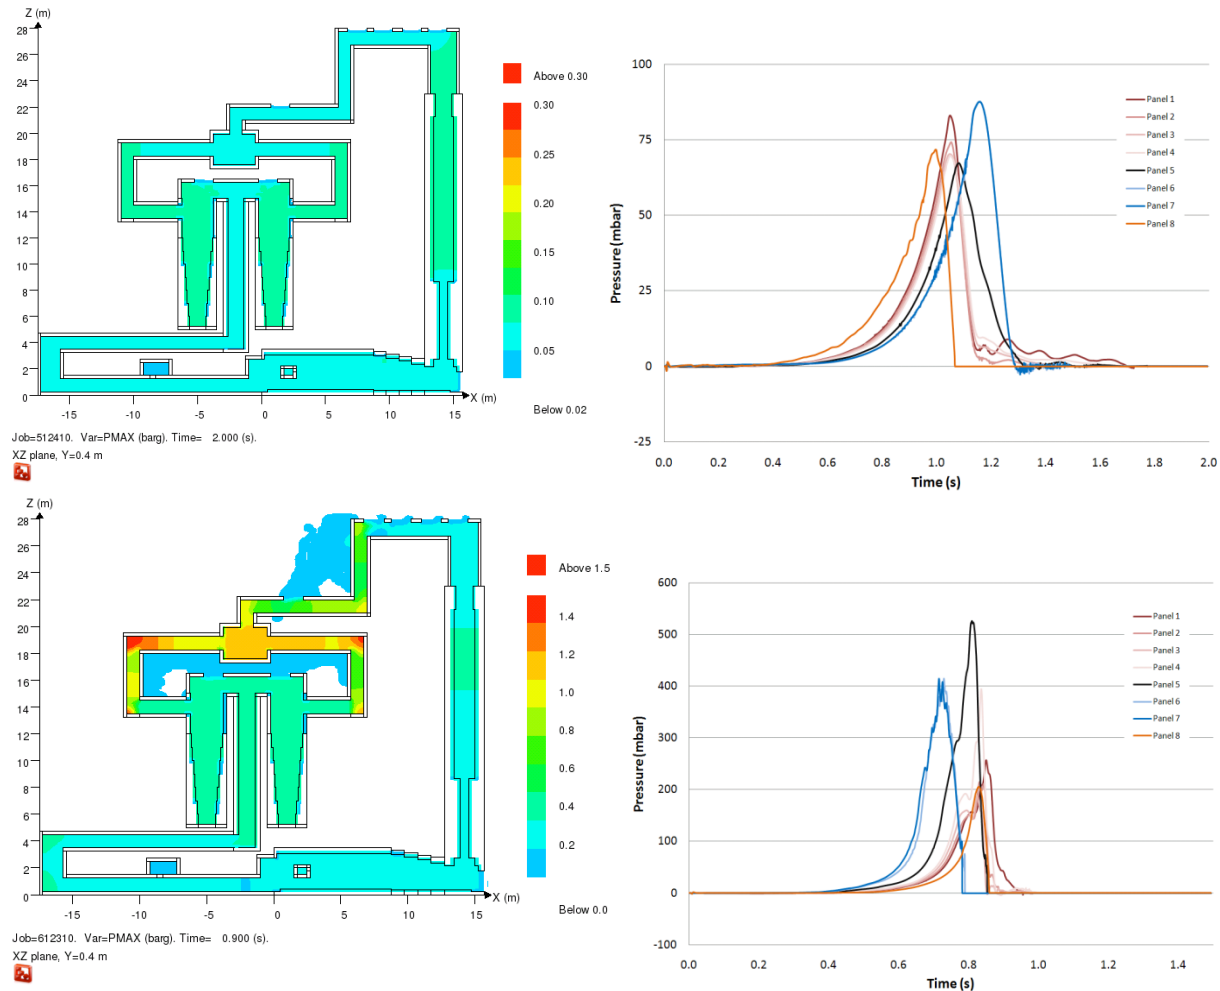
In Figure 14 some simulation results are shown, in both cases with the “realistic” flammable dust cloud assumption covering the region from the exit of the hot box to the cyclones. The initial temperature in the dryer is 120°C and a normal air atmosphere is assumed. The latter is a very conservative assumption as the process is normally oxygen starved. The first scenario is with a dust reactivity K_{ST} of 50 bar-m/s and ignition at the exit of the hot box. From the plots it can be seen that the explosion pressures are well controlled by the explosion vent panels, and the maximum pressure reported in the dryer is less than twice the panel opening pressure of 50 mbar.

The second scenario shown in Figure 14 is one of the sensitivity calculations with the significantly higher dust reactivity ($K_{ST} = 100$ bar-m/s) and ignition near the cyclones. In this

simulation overpressures of more than 1 bar are predicted between the cyclones and explosion panel 5. Explosion panels 1-4 have a positive effect of reducing the pressure level and keeping pressures below 0.5 bar in the pipes down towards the hot box.

Figure 14: Dust explosion scenarios with realistic dust cloud between hot box and cyclones. The upper plots show predicted explosion pressures for $K_{ST} = 50$ bar-m/s dust with ignition near the hot box, while the lower plots show predicted pressures for $K_{ST} = 100$ bar-m/s dust with ignition near the cyclones. Left plots are showing maximum pressure distribution in system during explosion, the right plots show vent panel pressure during explosion.

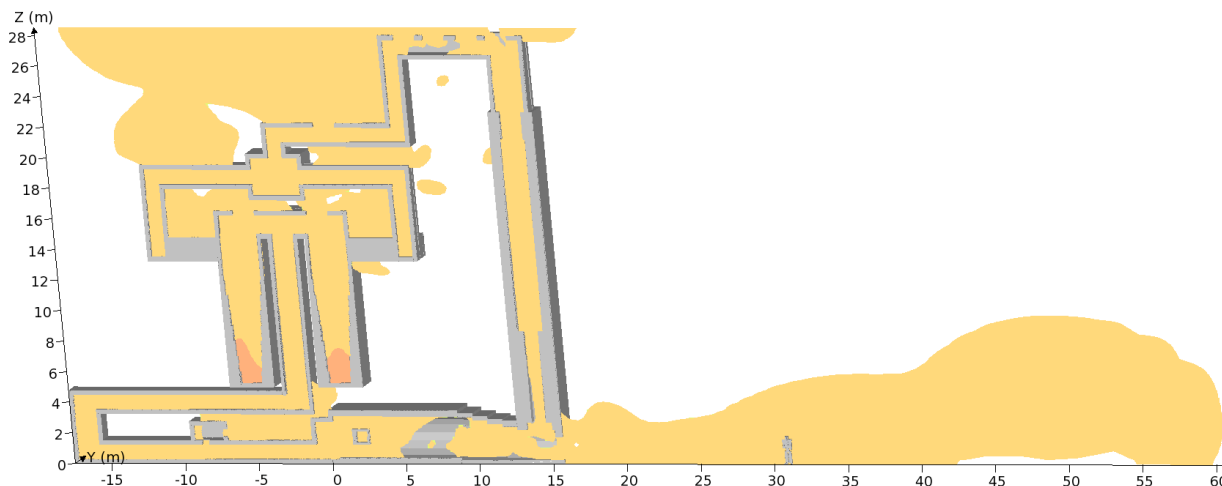
The incident caused significant damage and created numerous hazards. Some notable events included the failure of two explosion panels that became massive projectiles and the hot air box door blowing open and venting flames/hot combustion products into the facility. Explosion vents are to be located or retained so that personnel are not exposed to injury by operation of the vents. If the access door to the hot box is to be used as an explosion vent in the current configuration, personnel in front of the opening could be exposed to venting products of combustion and flames (see Figure 15).

Figure 15: Venting of products of combustion and flames during a dust deflagration via the access door in the hot box. Note the representative employee at 31 m.

3. The door to the hot box should be vented outside the facility, in the event it blows open during the venting of a dryer deflagration. This access door failed to meet the requirements of NFPA 86 *Ovens and Dryers*, which states, “Explosion-relief vents shall be located or retained so that personnel are not exposed to injury by operation of the vents.” While the door to the hot box may not have originally been considered an explosion vent, it can however serve such a purpose and safety design needs to be considered.
