Dust or Gas Explosion: Case Study of Dryer Explosion and Design Venting

Scott G. Davis
GexCon US
7735 Old Georgetown Rd., Suite 1010
Bethesda, MD 20814
sgdavis@gexcon.com

Prepared for Presentation at
American Institute of Chemical Engineers
2010 Spring Meeting
6th Global Congress on Process Safety
San Antonio, Texas
March 22-24, 2010

Keywords: dust explosion, gas explosion, explosion venting

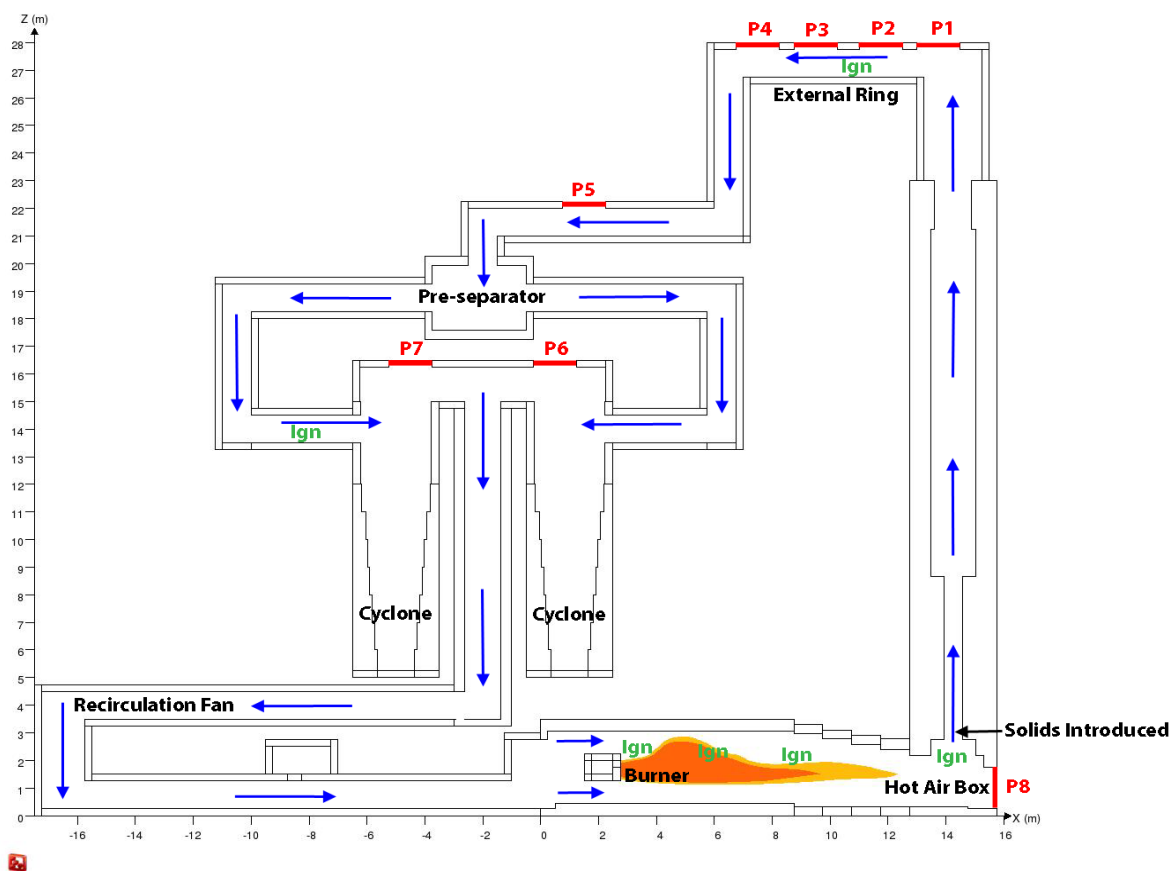
Figure 4: Schematic of facility solids dryer

Figure 4 presents a general schematic of the dryer at the facility. The dryer consisted of a natural gas fired burner around which the recirculating flow passed. The combined combustion products of the burner and recirculating flow mixed in the horizontal section of the ductwork and turned 90 degrees vertically at the hot air box. Solid material is added just above the hot air box and the material is conveyed up to the external ring section of the dryer, which has four hinged explosion panels installed on in this section of the duct (P1-P4). Downstream from the external ring, the material flows to a pre-separator, which removes some of the high moisture content material and re-introduces it into the hot box, and has an explosion panel installed (P5). After the pre-separator, the dried material is removed via the two cyclones (with two explosion doors P6, P7) and the remaining gases are circulated back to the burner. There was another door (P8) provided at the hot box to provide access for cleaning and removing accumulated solid material.

Given that ignition likely took place in the region between the burner and hot box, a number of ignition scenarios were simulated (see Figure 4). Ignition locations near the burner (2.5m, 5m, 10m) and more downstream of the burner were studied. For selected scenarios the strength of the access door to the hot box was increased from 50 to 100 mbar to see how this would influence the explosion development. In Figure 10 the maximum reported pressures and vent panel pressures for one of the scenarios ignited at 7.0 seconds are shown. Note that the explosion panel pressure will go to zero once the panel is opened, and that pressures reported higher than the 50

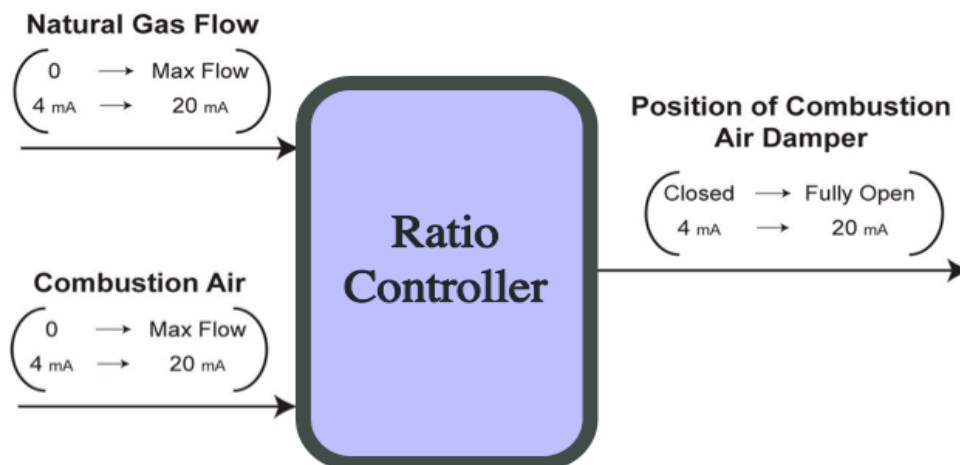
Figure 5: Schematic functionality of the ratio controller

The combustion air is metered using a mass flow meter, which in turn transmits a signal in the 4 mA to 20 mA range to the ratio controller. The mass flow meter output signal limits of 4 mA and 20 mA correspond to no airflow and maximum airflow conditions, respectively. Based on the measured fuel flow rate, the measured airflow rate and the control condition (thermal turndown or ratio control), the ratio controller will provide an output signal in the 4 mA to 20 mA range to position the combustion air damper. The ratio controller's output signal limits of 4 mA and 20 mA correspond to the fully closed and fully open position of the combustion air damper, respectively.

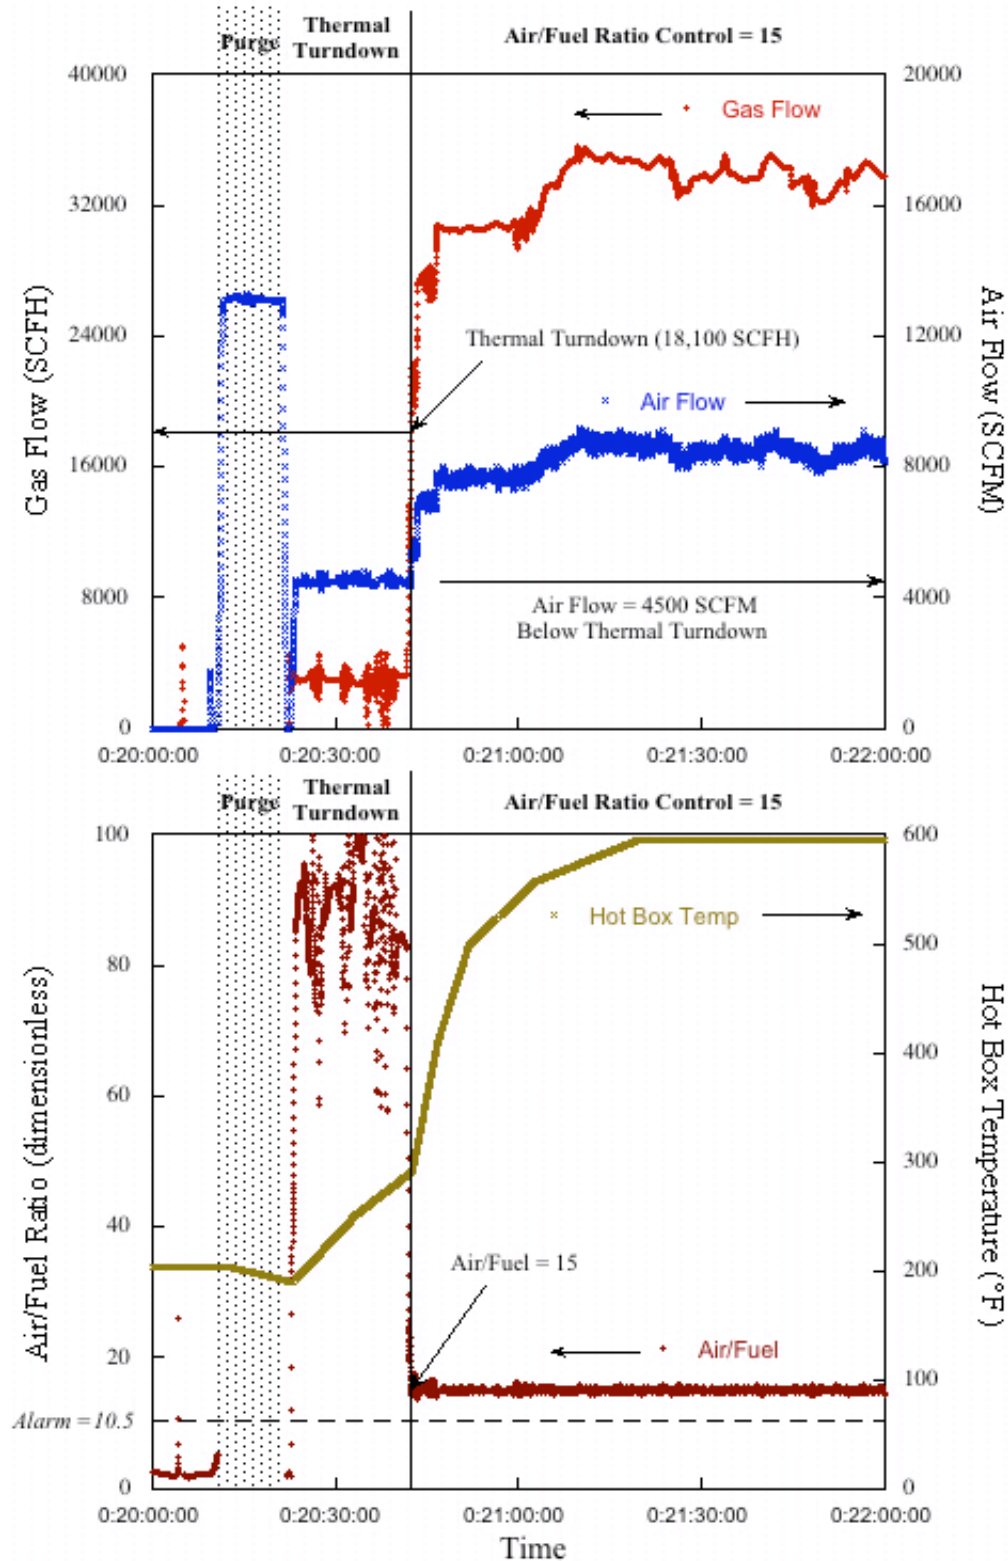
Figure 6: Process data for a typical relight of the dryer

Figure 6 shows several process variables (gas flow rate, combustion air flow rate, hot box temperature and air/fuel ratio) during a typical relight of the burner in Dryer B. The system is configured for a 10-minute purge period, where the combustion damper is driven to the fully open position and the gas valves are closed, as shown in the shaded areas in Figure 6. The burner is initially relit in a low-fire mode (thermal turndown), where it is maintained for 20 minutes.

After this warm-up period the gas flow rate was increased and product was added to the dryer. As the gas flow rate increased past 18,100 SCFH, the combustion airflow was proportionally controlled to the air/fuel ratio of 15/1. This ratio was maintained fairly steadily while the hot box gradually reached its typical operating temperature of approximately 600 °F. Also shown in Figure 6, is the ratio controller alarm that was specified to activate when the air/fuel ratio drops below a ratio of 10.5/1. To avoid nuisance trips, the air/fuel ratio must remain below this set point for 4 seconds to activate the alarm.
